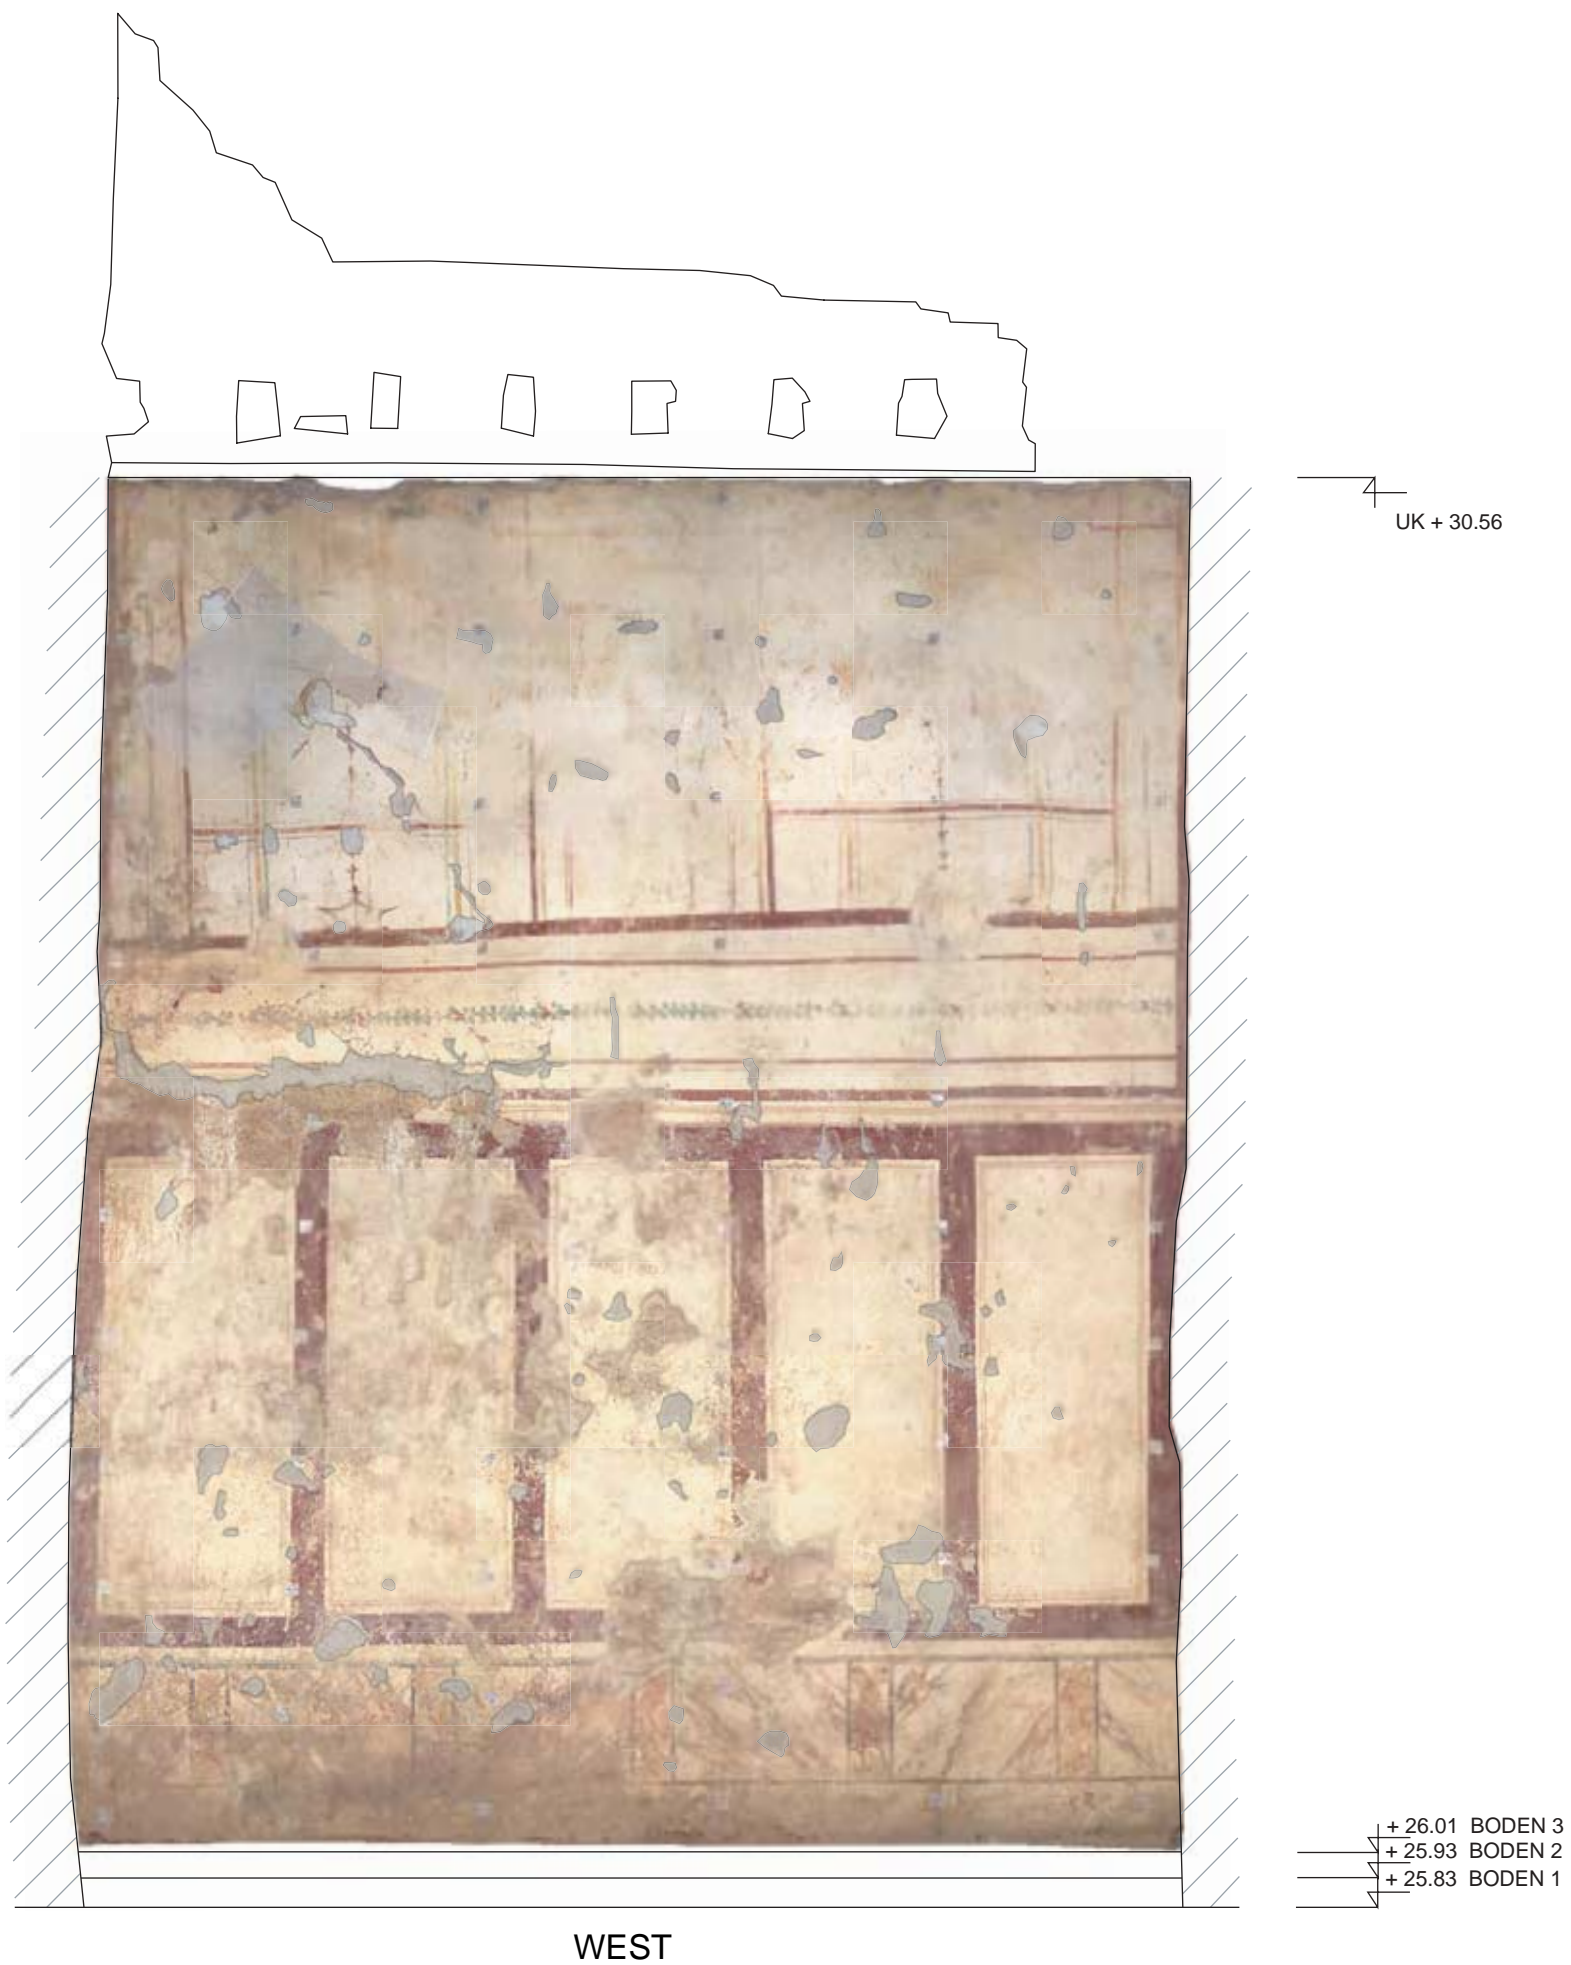
62: Bilddokumentation Raum 15, W-Wand (M 1:25)

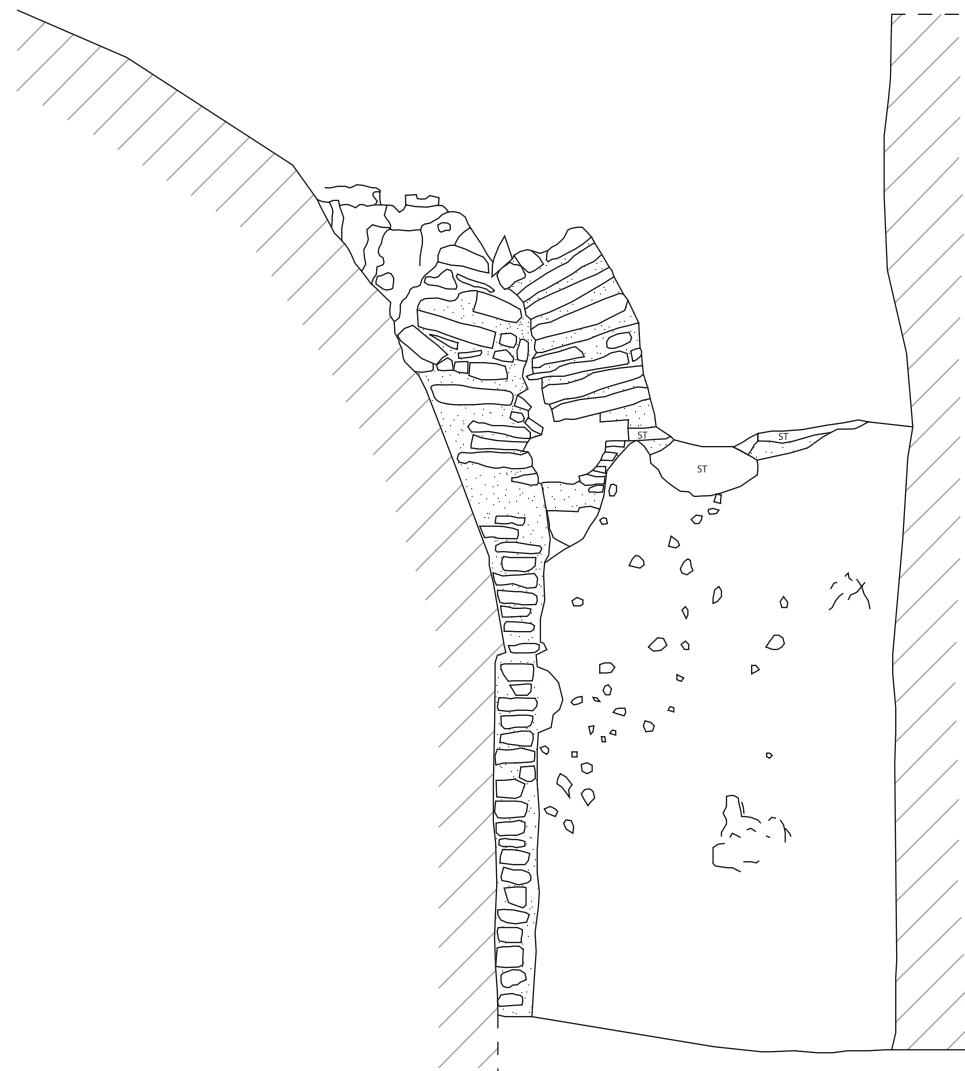
63.1: Z Raum 23, O-Wand (M 1:25)

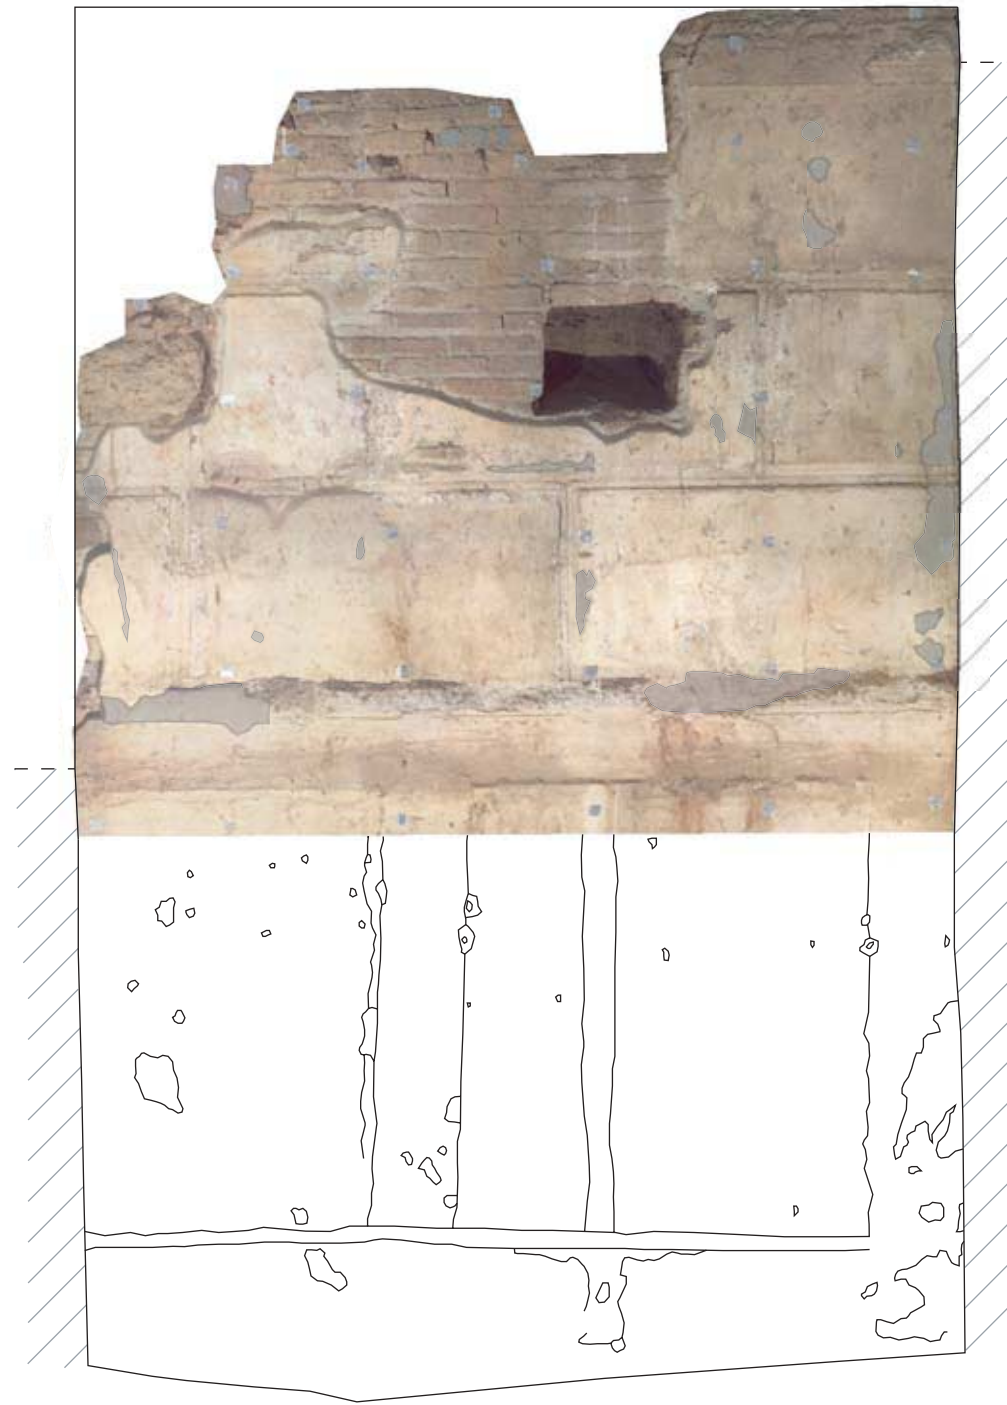
63.2: Bilddokumentation-Z Raum 23, S-Wand (M 1:25)

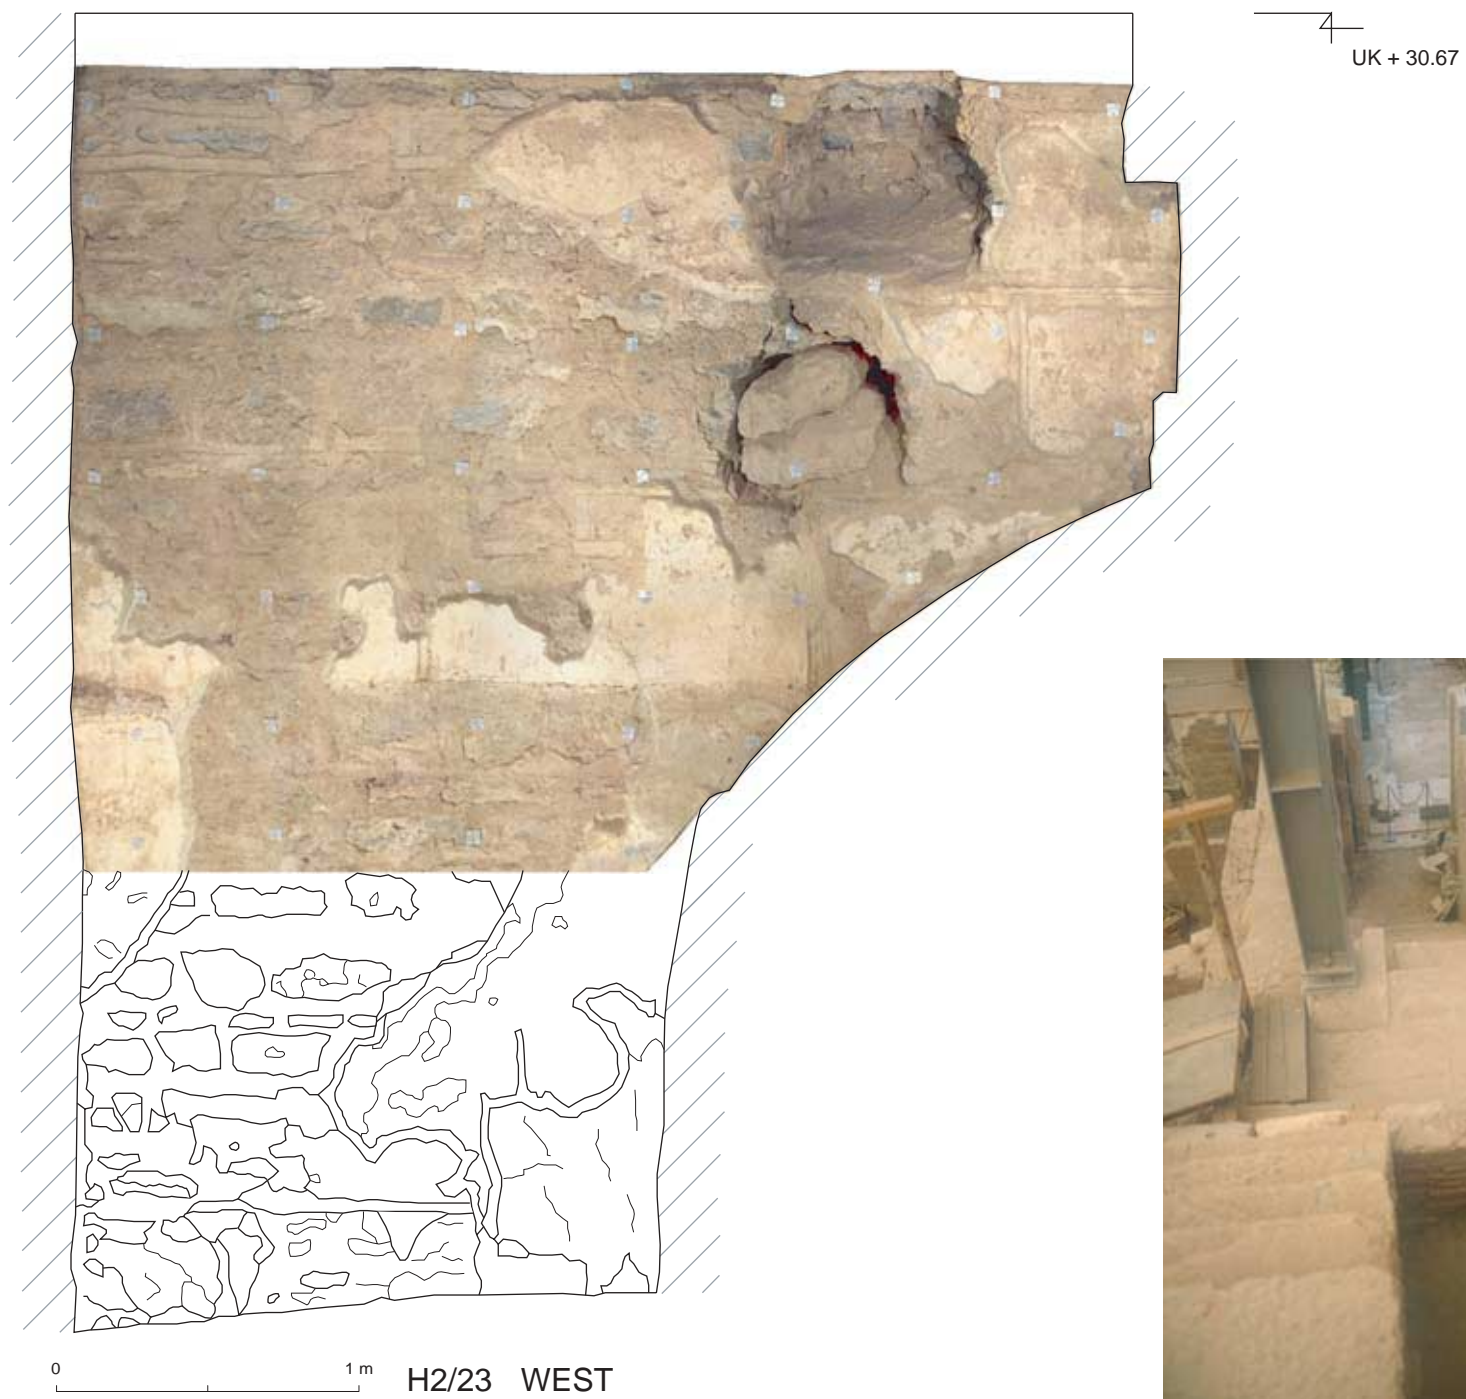
64.1: Bilddokumentation-Z Raum 23, W-Wand (M 1:25)

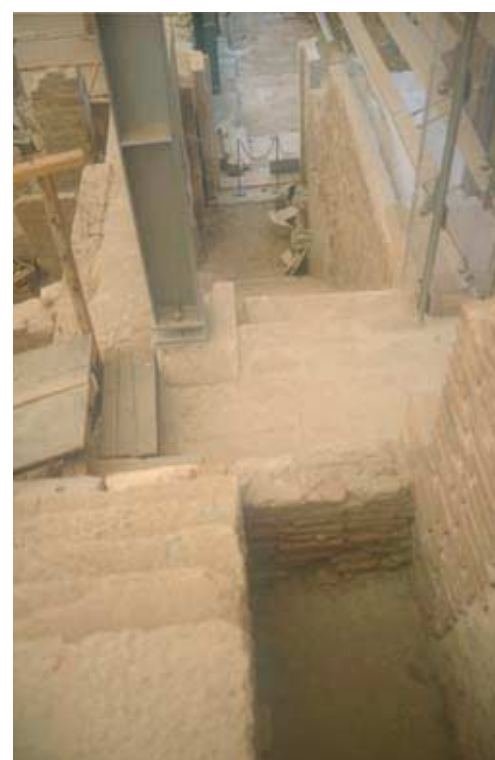
64.2: Raum 1 mit Resten der Nordwand

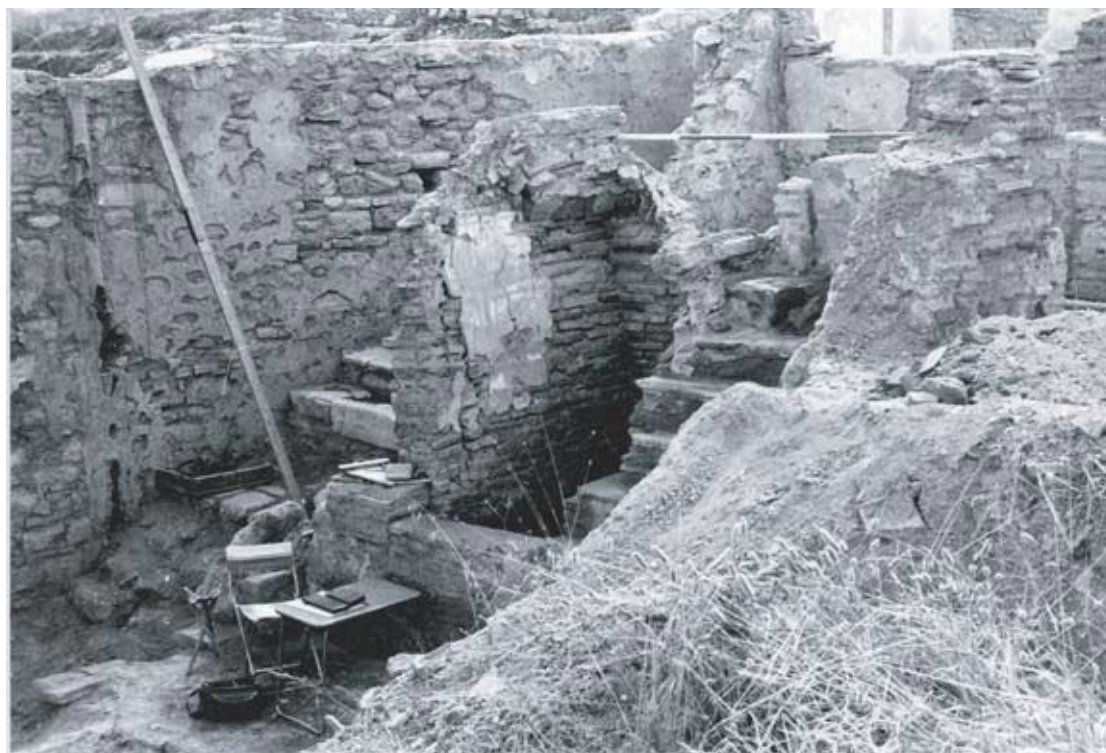
64.3: Raum 1 mit Stiege ins 2. OG, Grabungsphoto

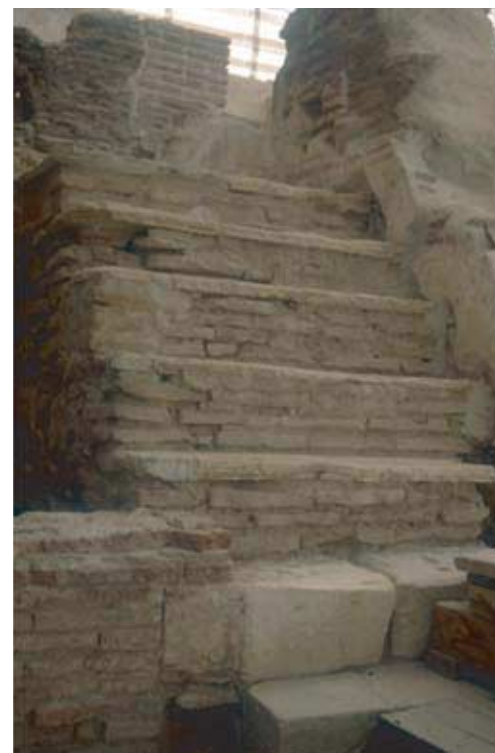
64.4: Raum 1, Treppe ins 2. OG

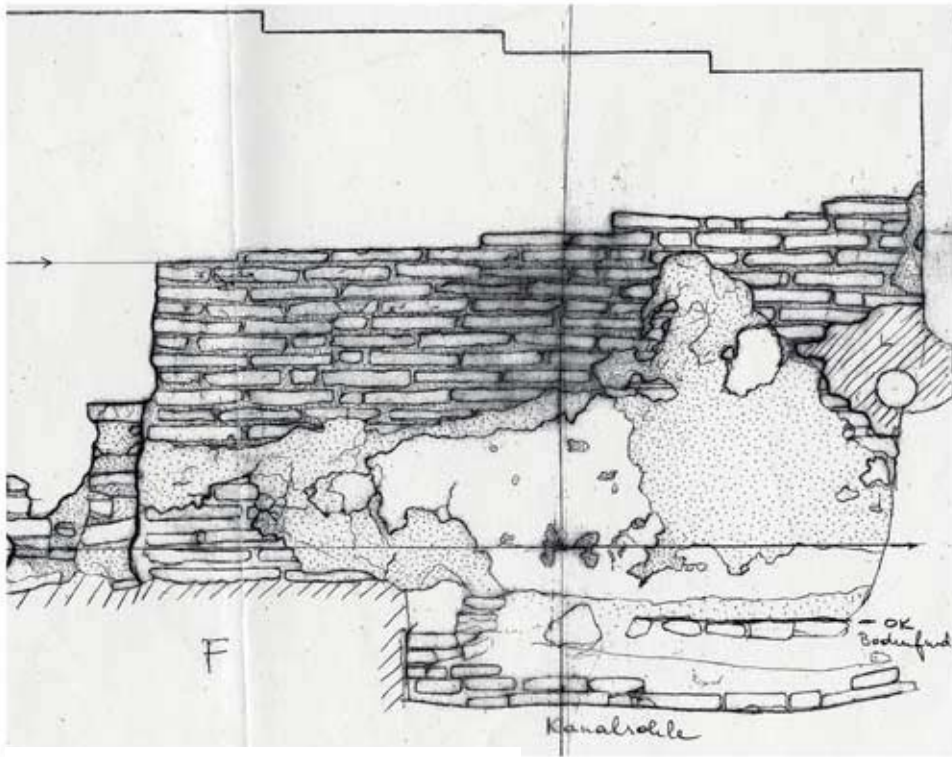
65.1: Z Raum SR 5d, S-Wand (M 1:25)

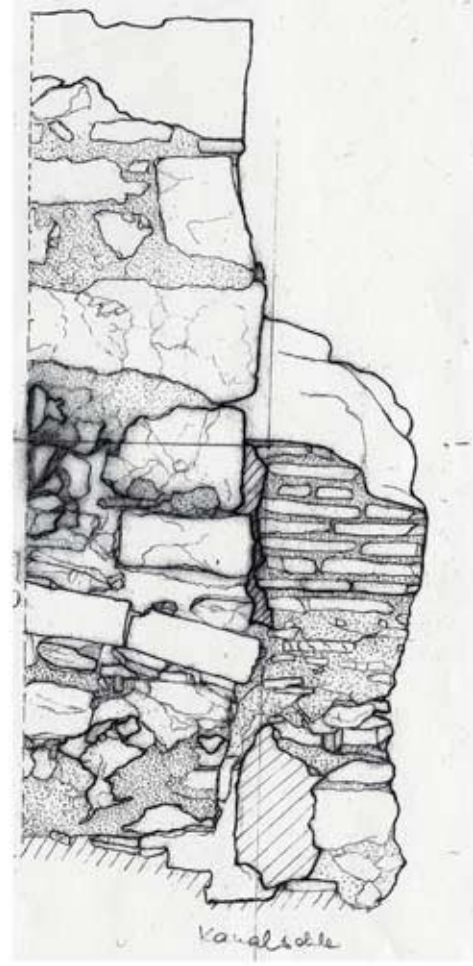
65.2: Z Raum SR 5d, W-Wand (M 1:25)

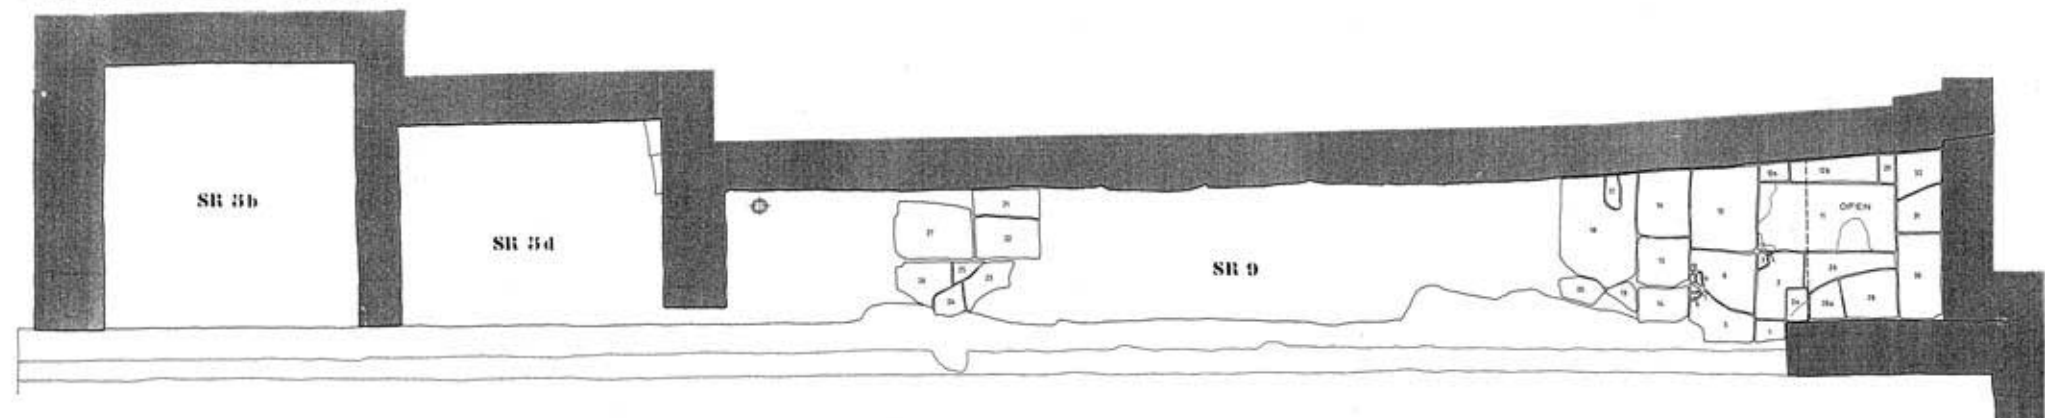
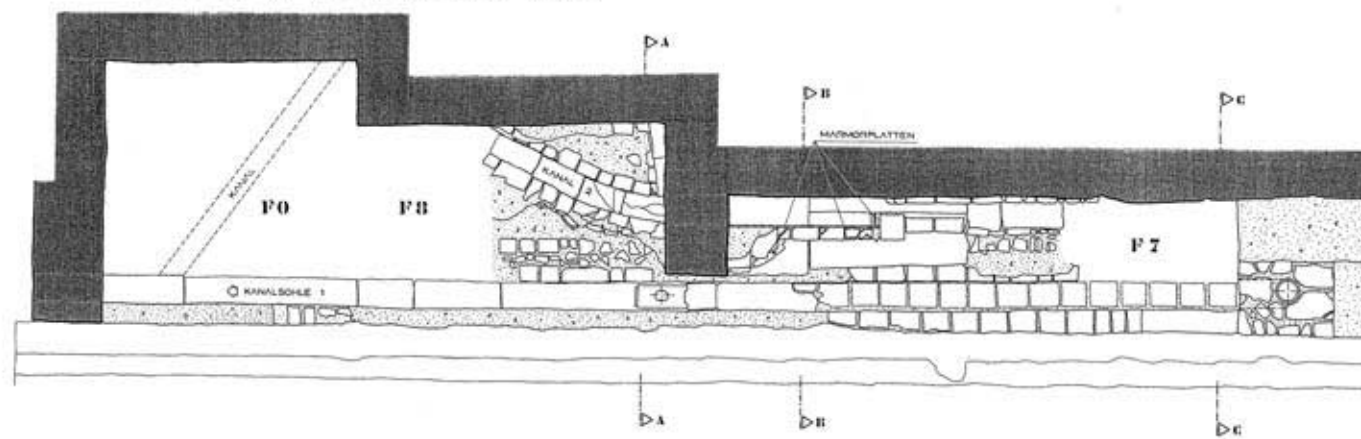
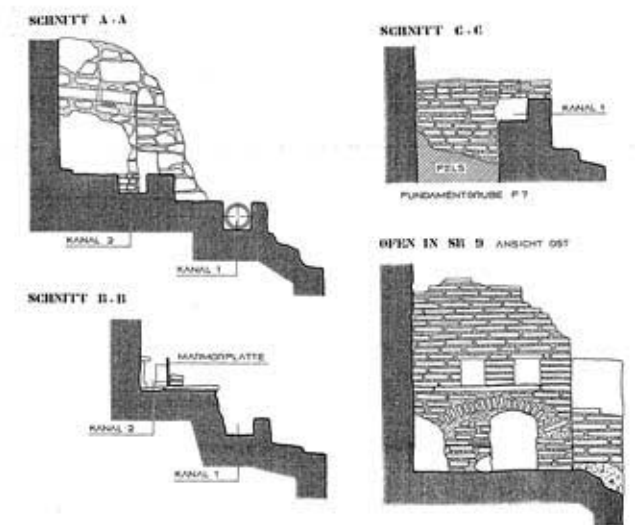
BODENPLATTEN IN SR 9

KANALSYSTEM IN SR 5b,d und SR 9

66: Fundamentgrabung in den Räumen SR 5b, SR 5d, SR 9 (M 1:75)

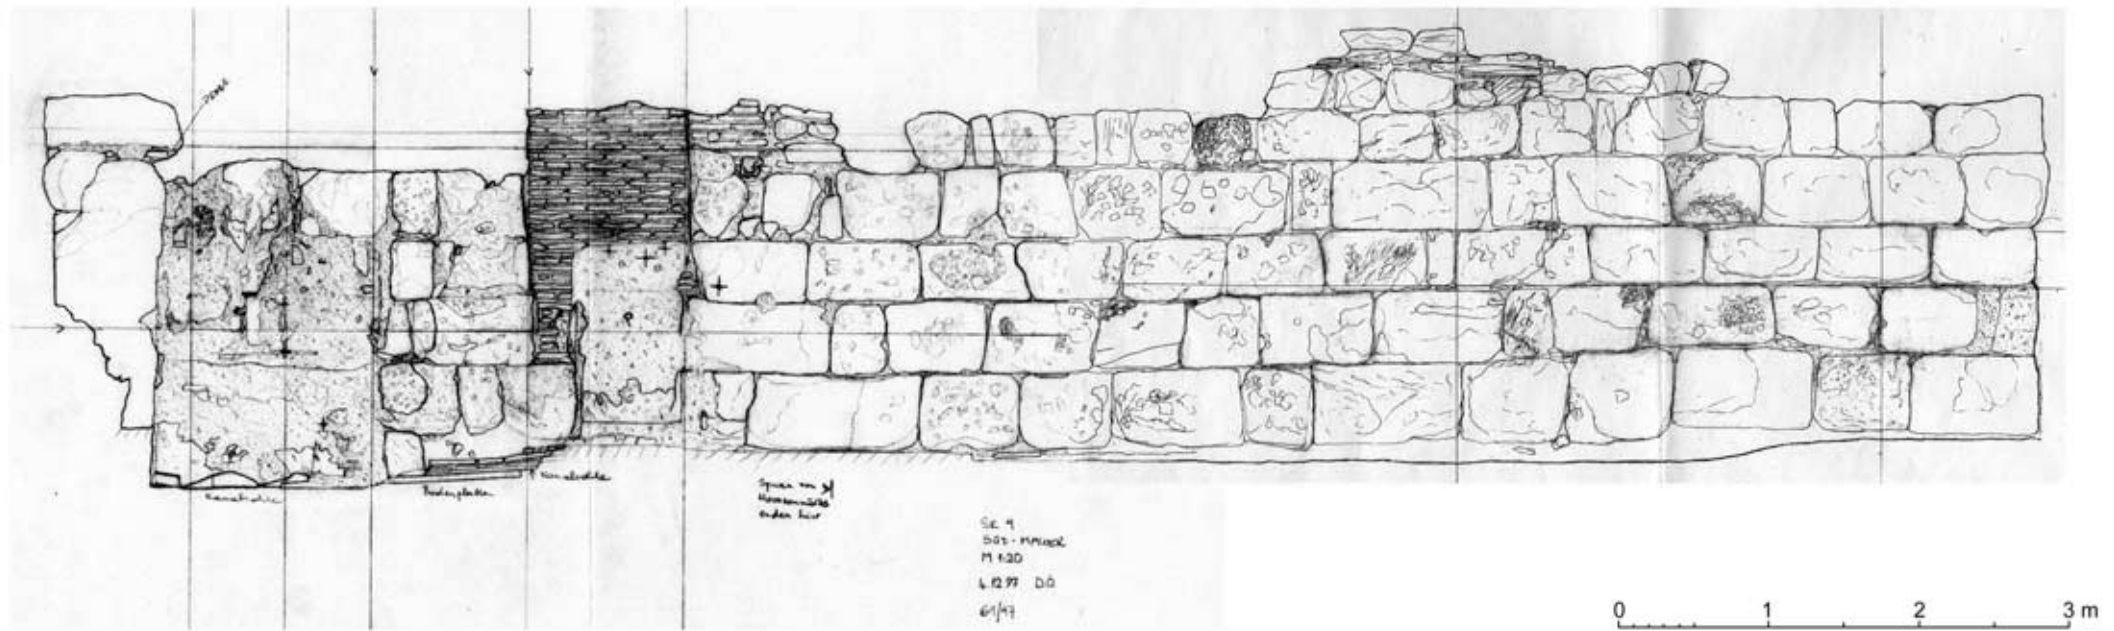
67.1: Z Raum SR 9, S-Terrassenmauer (M 1:50)

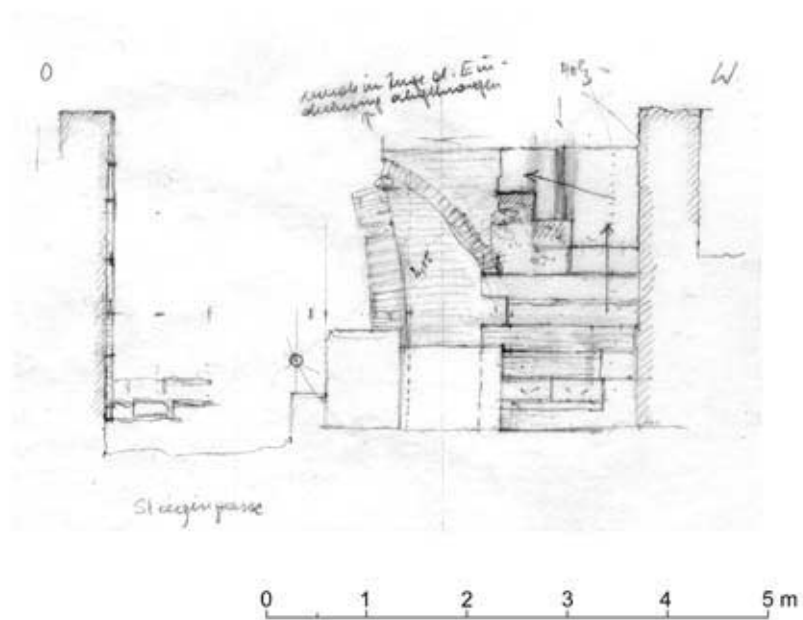
67.2: Z Raum 1 mit Stiege ins 2. OG (M 1:75)

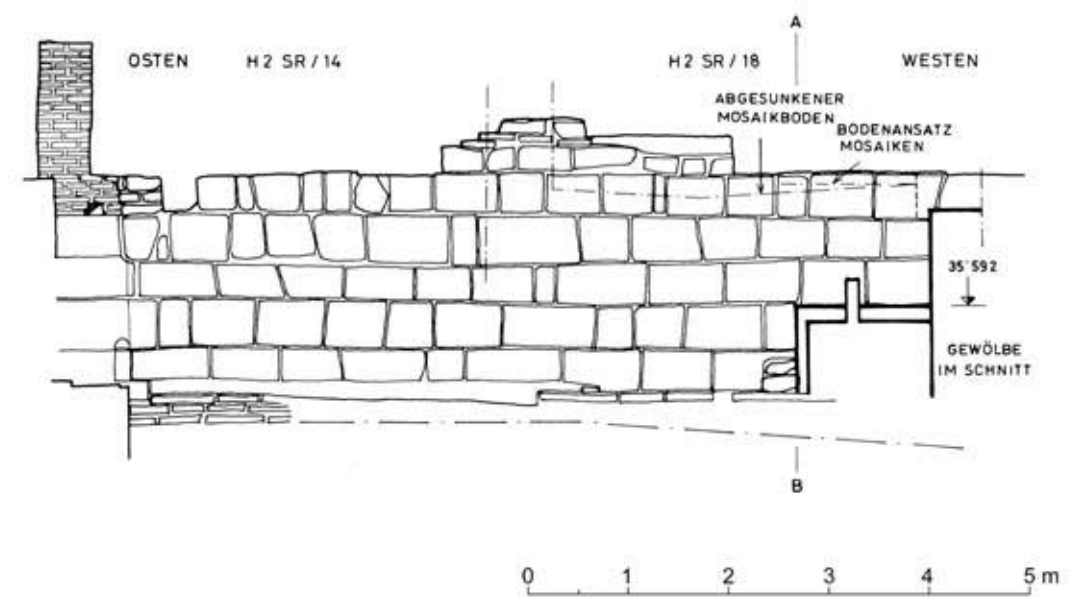
67.3: Z Raum SR 9, S-Terrassenmauer mit Schnitt Ofen (M 1:75)

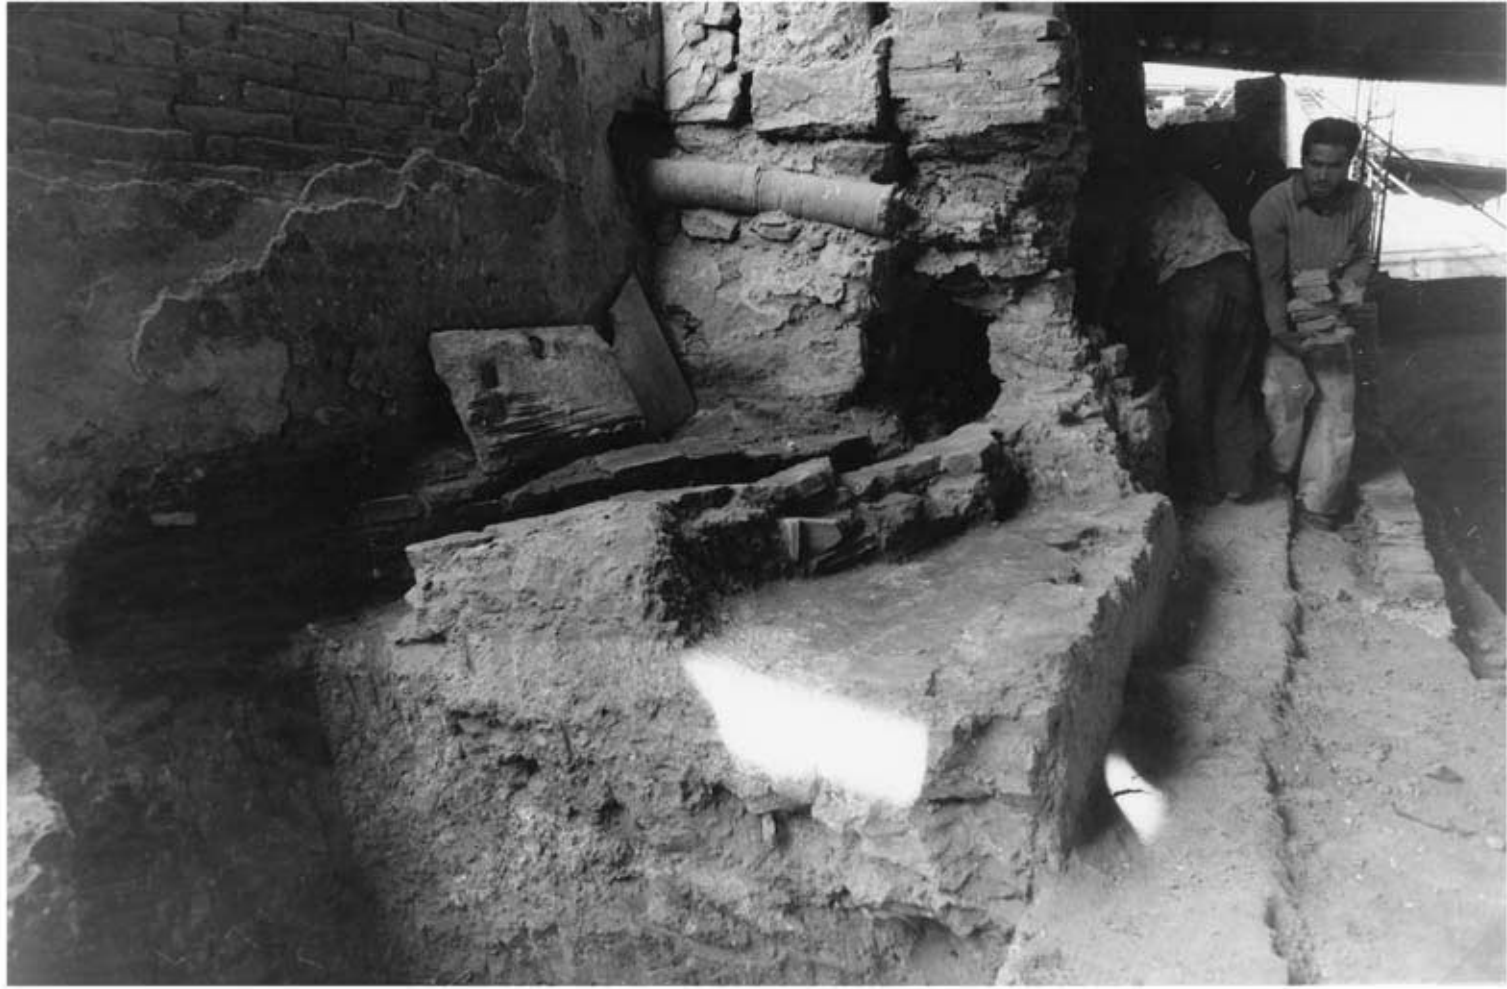
68.1: Raum SR 5d, Grabungphoto 1979

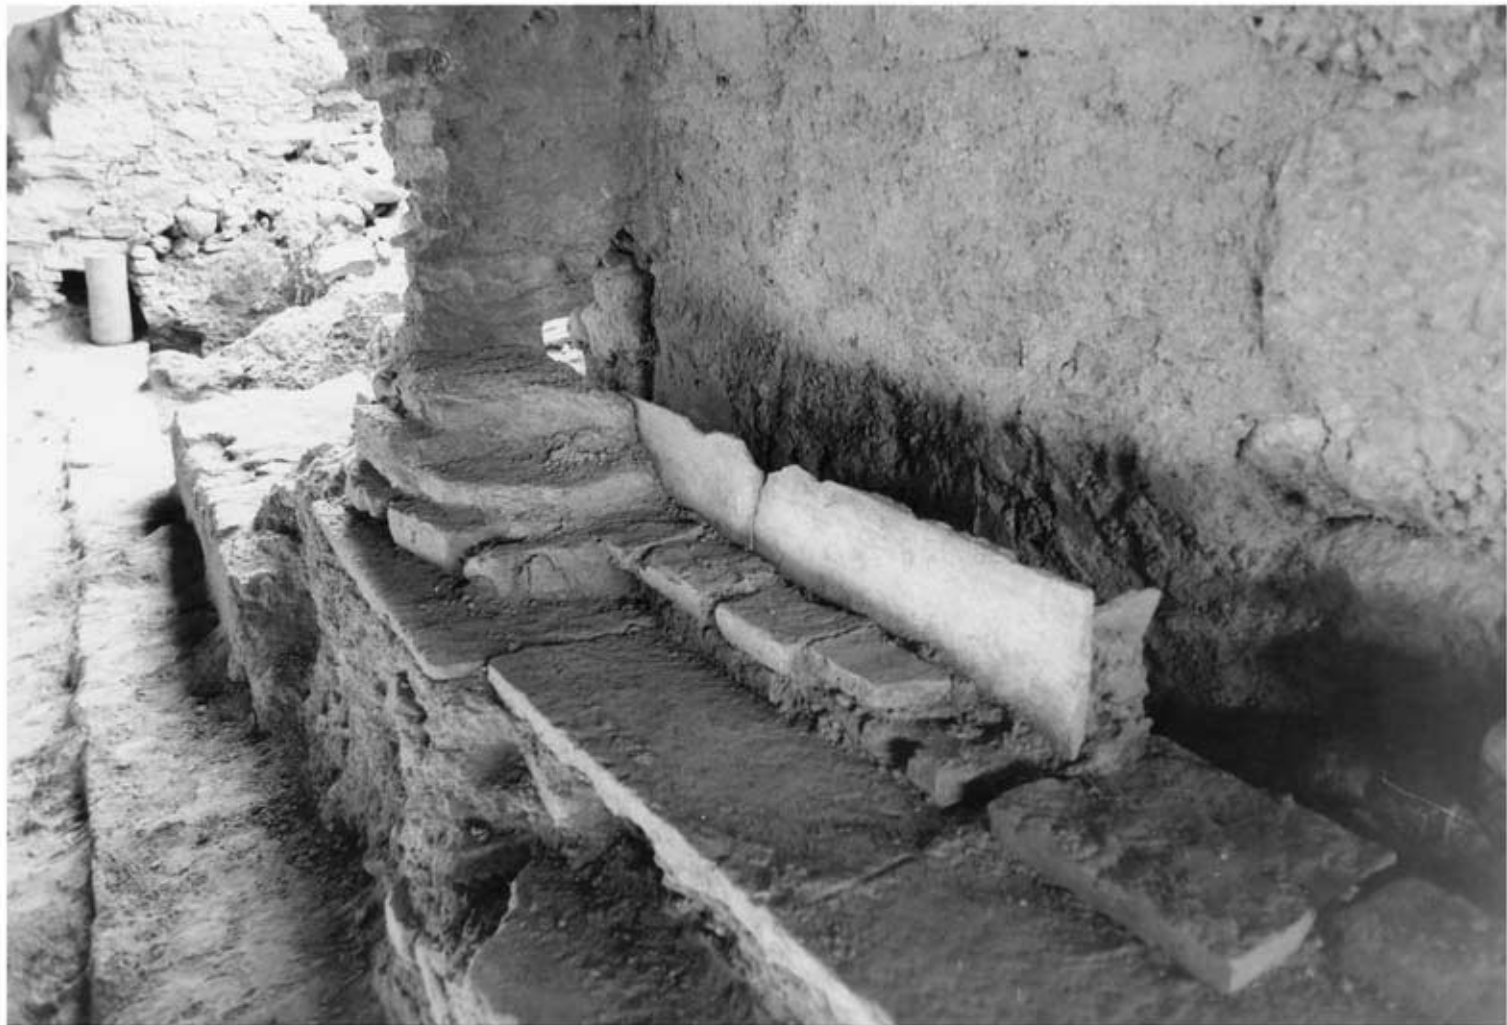
68.2: Raum SR 9a, Grabungphoto 1979
